Manhole Inspection Summary

Manhole # S17C1_021MH

Insp Date: **5/19/08 10:58 AM**

Location Address: **1900 deering av**

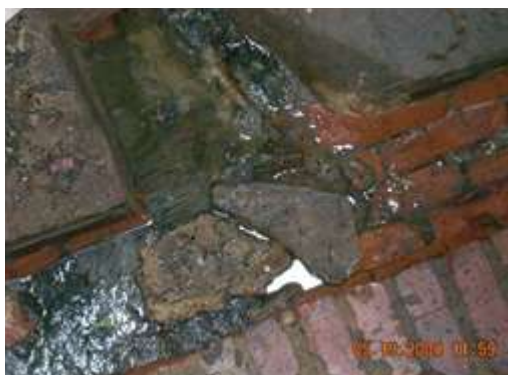
Defect 3

Condition: ☐ Sound ☐ Cracked ☐ Root Intrusion ☐ Deteriorated ☐ Leaks ☒ **Debris**

debris in channel

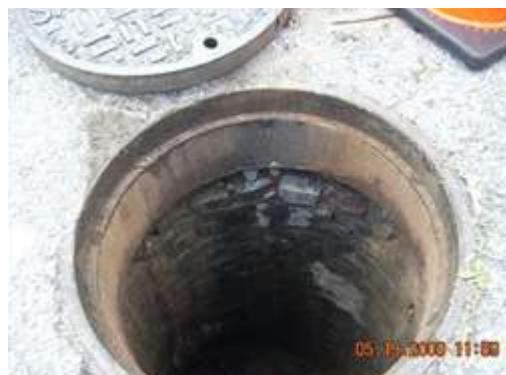
Defect 2

Infiltration: ☐ None ☒ **Joint** ☐ Cracks ☐ Mortar ☐ Roots ☐ Wall

Infiltration @ chimney Joint; inflow evidence from sheeting

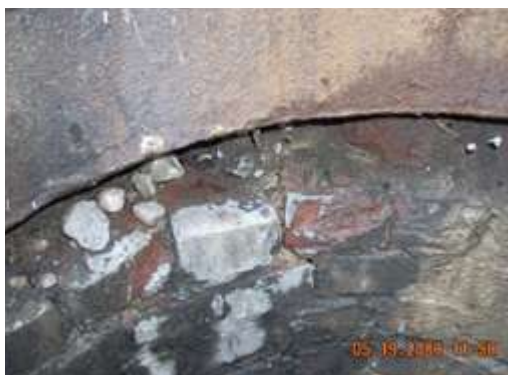
Defect 1

Condition: ☐ Sound ☐ Cracked ☐ Root Intrusion ☐ Loose Brick ☒ **Deteriorated**

deteriorated chimney

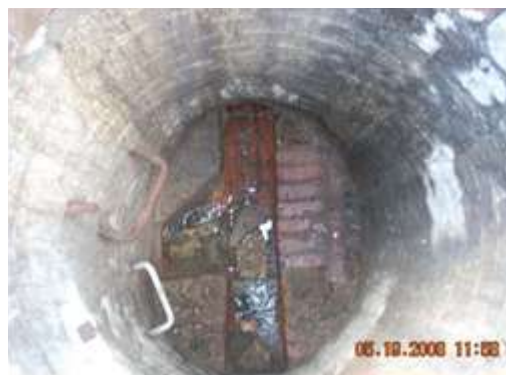
Defect 4

Count: **2** Missing: **1** ☒ **Corroded**

Corroded Steps

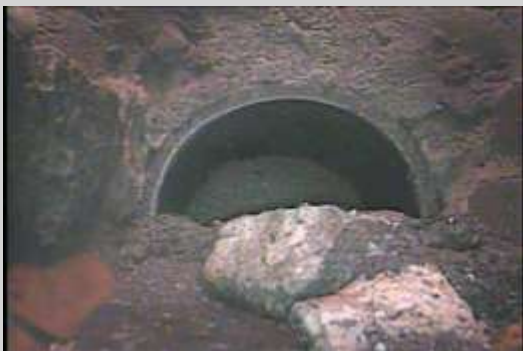
6 O'Clock Inflow

Pipe Height: **3.6** (in.) Rod and Bar (Angled)
Pipe Material: **Clay** ☐ Pipe Lined
Invert Depth: **0.00** (ft.) Flow Characteristics: **None**
Deposits: ☐ None ☒ Mud ☐ Gravy ☒ Debris ☐ Grease
Silt Depth: **4** (in.) Deposits Extent: **Heavy**
Infiltration: **None** Pipe Seal Cond: **Sound**

Connects To: **Stub connection / abandoned**

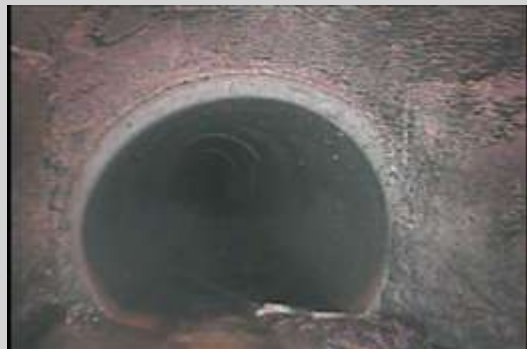
9 O'Clock Inflow

Deposits: ☐ None ☐ Mud ☒ **Sludge** ☐ Debris ☐ Grease

Silt Depth: **1** (in.) Deposits Extent: **Light**
